Multistorey Car Park, Earls Way, Orpington
- Redevelopment by Tesco Plc (Application No. 04/03193/Full1)
Supplementary Evidence on the Existing Traffic Conditions
near the Proposed Development

Prepared on behalf of O.C.P.A.G. by Roger Lawson 20/9/2004
Telephone: 0208-467-2686; email: roger.lawson@btclick.com

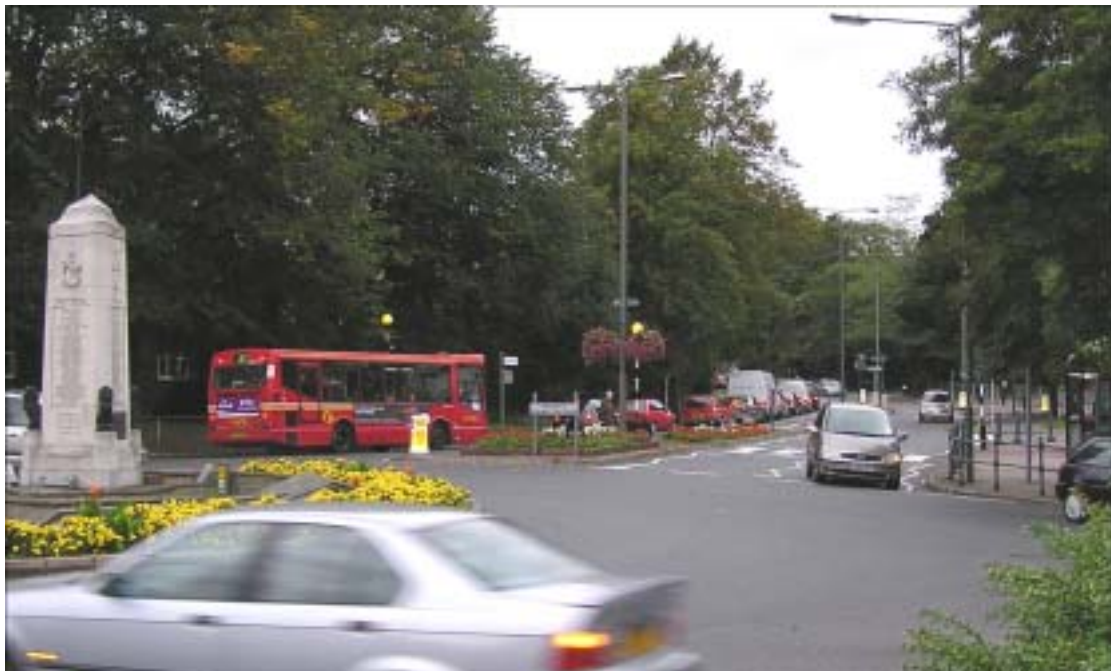
The first photograph shows the queue on Station Road, looking up the hill. This is formed by vehicles attempting to reach Orpington Station and congestion around the station during rush hours for commuters. The proposed Tesco store would be sited to the immediate right of this picture.

As you can see from the fact that the vehicles in the queue have their brake lights on, this queue is stationary.

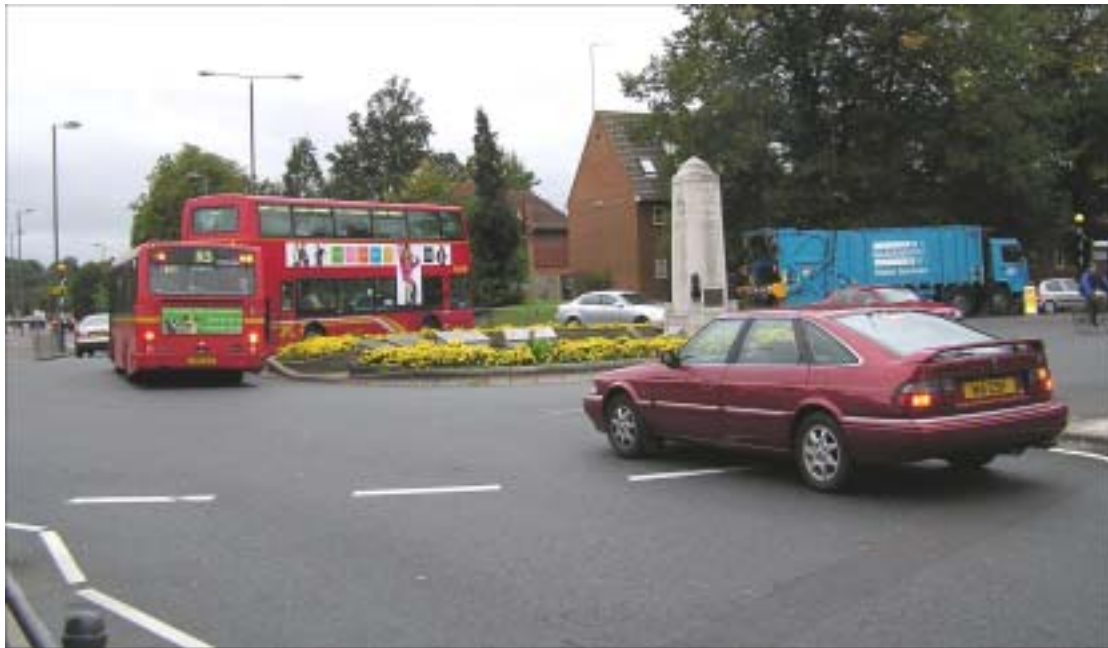
The next photograph shows how the previously mentioned queue blocks traffic on the war memorial roundabout (this view is taken from Orpingto High St and Station Road is the exit to the right).

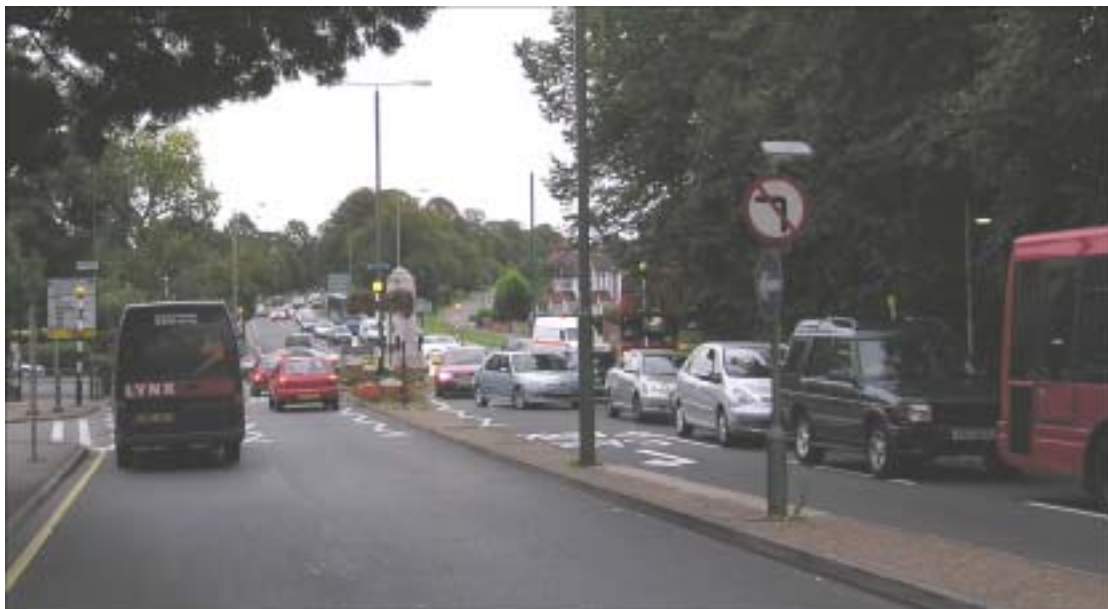
The following photograph shows the queue on Station Road looking down the hill, and across to Spur Road.

It can be seen that a considerable queue of traffic forms on Spur Road as a result and actually stretches out of sight but is at least 11 vehicles long in this photograph.

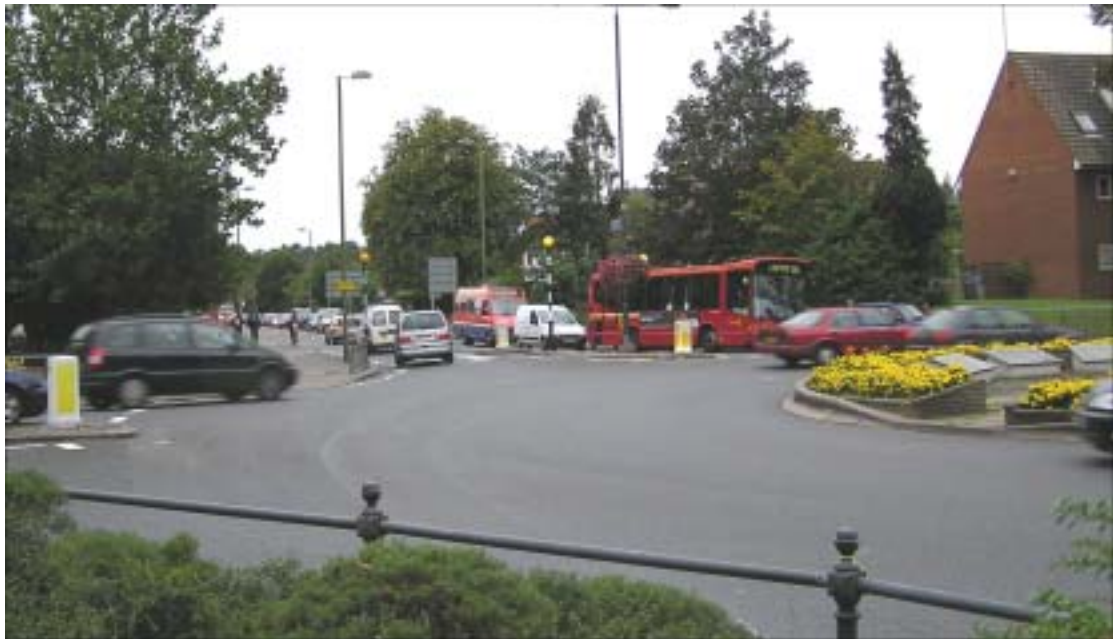
The next photograph shows that a similar queue up to the roundabout forms on Sevenoaks Road, partly caused by vehicles being blocked from exiting the roundabout up Station Road.

The queue of vehicles on Sevenoaks Road also stretches out of sight, but is at least 10 vehicles.

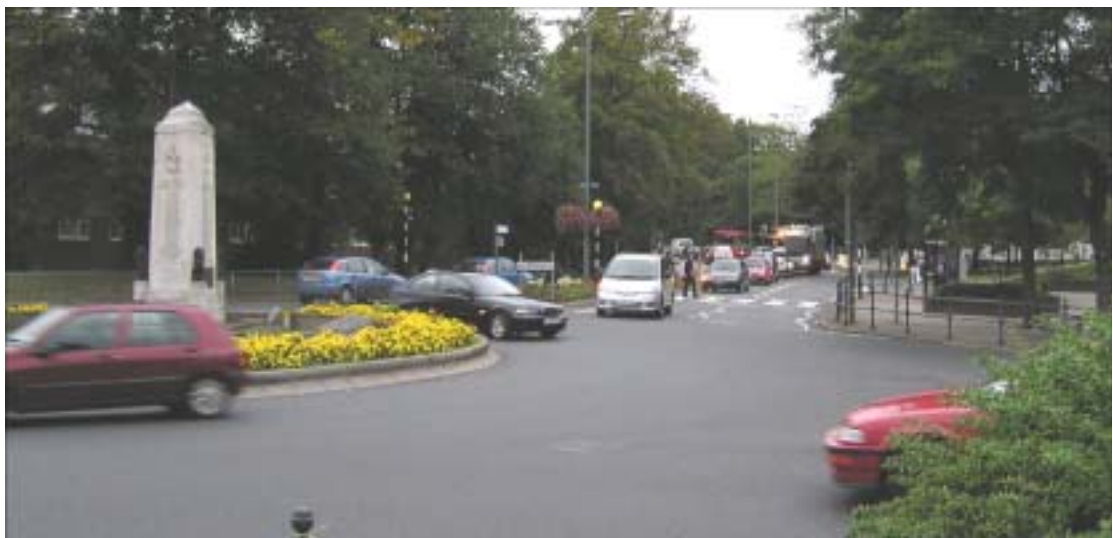
The following photograph shows another view of Station Road. In this case not only is there a queue up the hill, but also a considerable queue of traffic down the hill up to the war memorial roundabout. This is exacerbated by pedestrians crossing on the zebra crossing just before the roundabout, as shown in the photograph.
